**HaskoningDHV Nederland B.V.
Industry & Buildings**

Subject: Holyhead Waterfront Development - Great Crested Newt Pond Survey

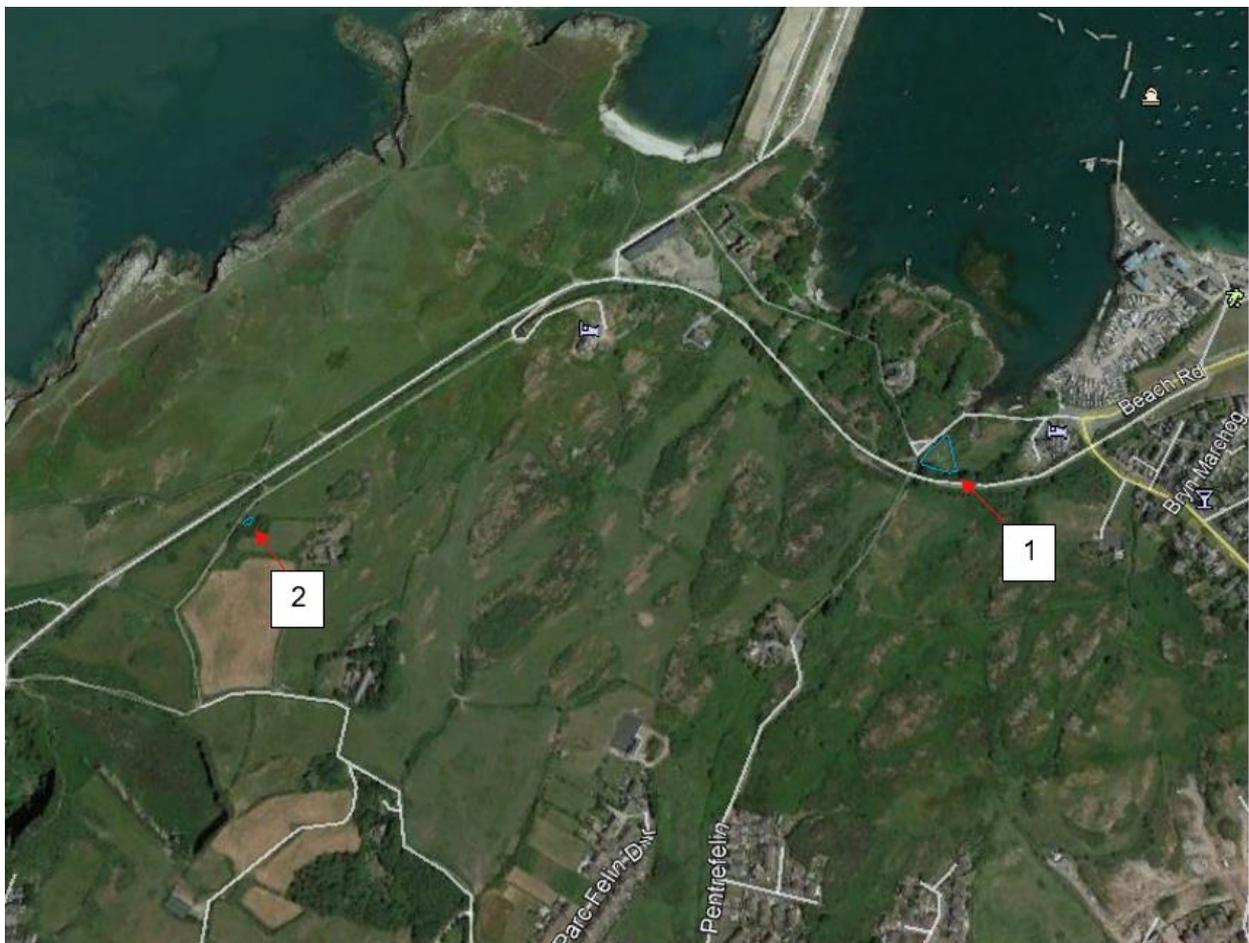
Figure 1 Locations of ponds

The two identified ponds within the Holyhead Waterfront Development study area were visited on the morning of Thursday 27th June with the intention to take water samples for eDNA analysis, in order to determine the presence or absence of great crested newts (GCN). The locations of the ponds are shown in Figure 1 below.

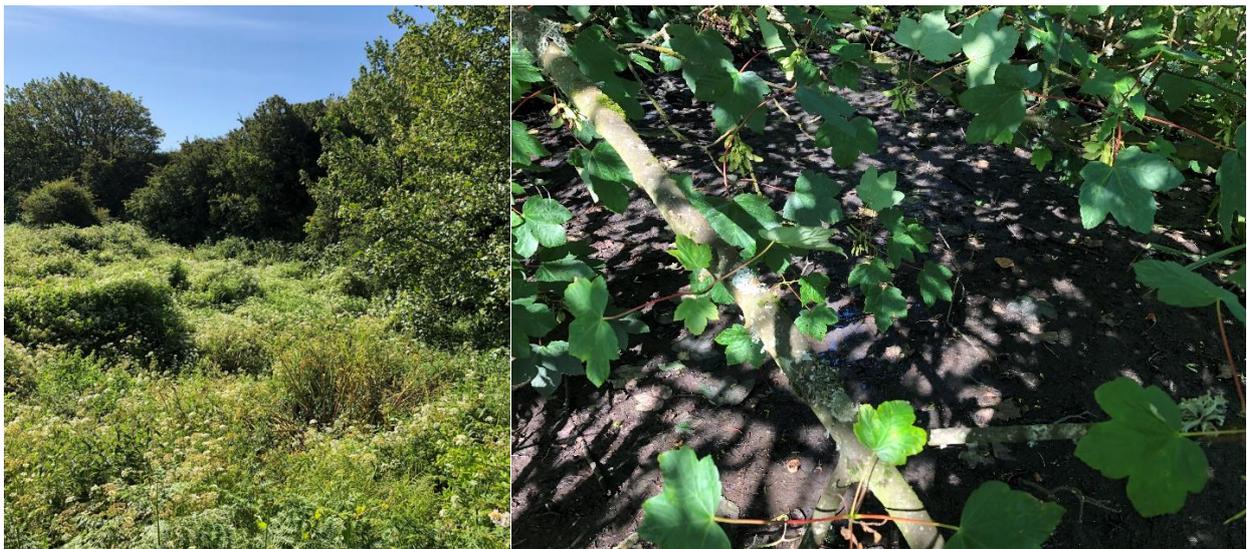
Figure 2 a) Pond 1 viewed from the western boundary looking east, and b) area under sycamore tree

The identified pond area was found to be dry and fully vegetated, suggesting that if a permanent pond has existed it has now silted up (Figure 2a). There was a wetter, unvegetated area under a mature sycamore at the western corner but no water was present (Figure 2b). It is likely that the area is subject to intermittent flooding following periods of rain but that any standing water is ephemeral and unlikely to persist long enough to support GCN breeding.

a)

b)

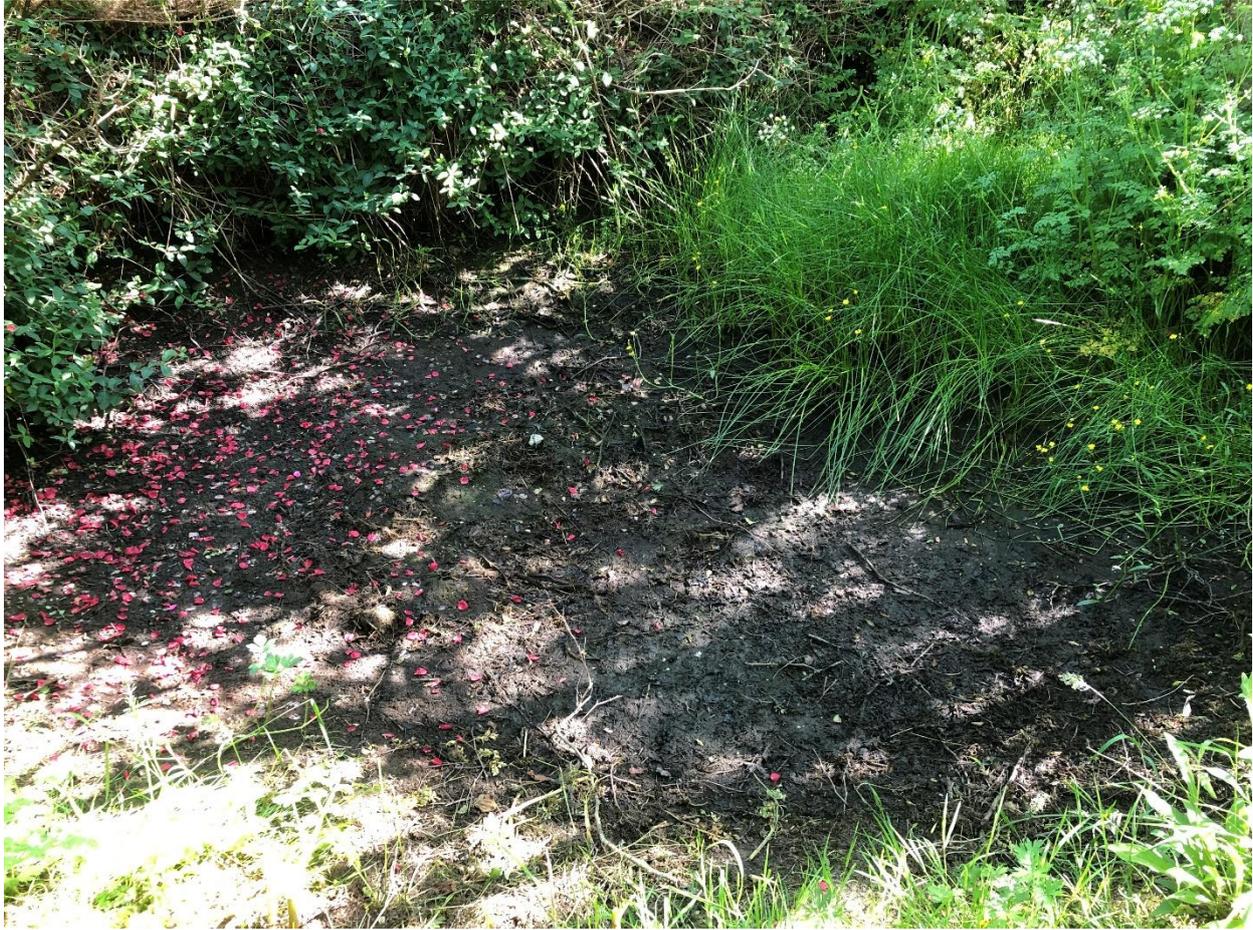
Figure 3 Pond 2

Pond 2 was found to be dry (Figure 3). There was a clearly identifiable pond area under tree cover but any standing water is ephemeral and unlikely to persist long enough to support GCN breeding. There was no evidence of aquatic vegetation.
